# HAZARD ALERT

## HOOK SMASHES THROUGH WINDOW, STRIKES WORKER

*An operator received head and facial injuries while he was attempting to transfer a roll-off waste container from a flat bed truck onto the bed of his roll-off truck.*

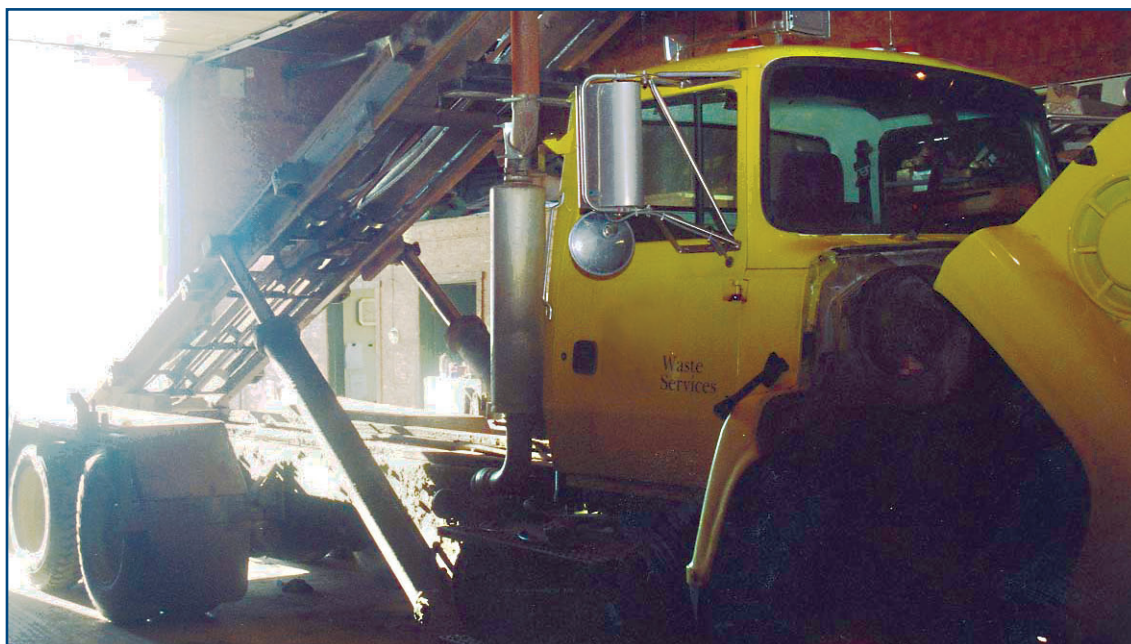
A winch cable was mounted on the roll-off truck, but it was not long enough to reach the container. In order to pull the container, the operator used a grab chain with a small  $\frac{5}{16}$ " cast hook, and used it between the container and the  $7\frac{1}{2}$ -ton-rated hook on the end of the winch cable. Once the container was positioned at the edge of the flat bed, the operator tried to pull the roll-off container onto the roll-off truck. Because the bed of the roll-off truck was not tilted enough to allow the container to properly roll onto it, the container got caught against the back-end of the roll-off truck bed. The winch continued to pull, but the container did not move, causing the small hook on the grab chain to break. The  $7\frac{1}{2}$ -ton-rated hook and winch cable whipped back toward the rear window of the cab, where the operator was facing backward to observe the operation. The hook went through the rear window and struck the operator in the forehead.

- No chain, rope, or any other connecting device between the winch cable and the container is to be used.
- The winch cable hook must have a safety latch so that the hook cannot inadvertently become unhooked.
- The bed of the roll-off truck must be tilted as per manufacturer's instructions, so that the operation can be accomplished safely.
- The rear window of the roll-off truck should be provided with adequate protection such as a screen, shield, grill, deflector or guard so that the operator is protected from the hazard of flying or intruding objects.
